Review of Avalon North End Beaches

March 28, 2018

Brief Summary of March, 2018 Storms

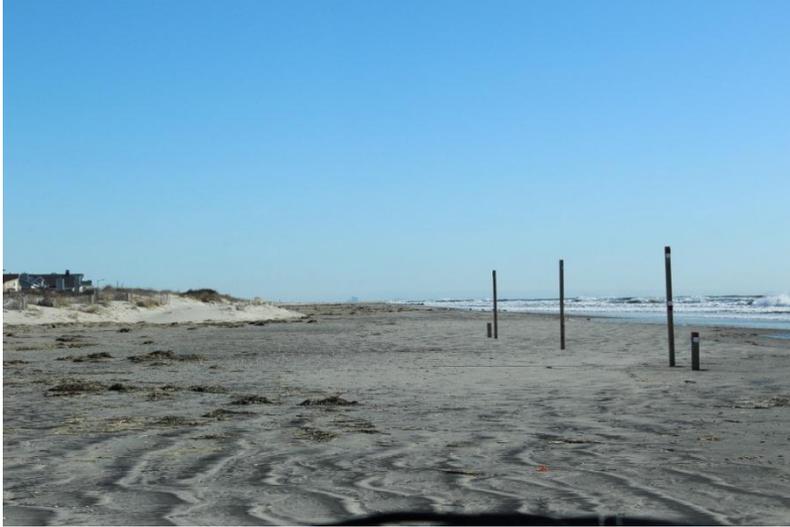
This is Avalon's beachfront with a view from 30th Street looking north taken on Monday, March 5th. Evidence of salt hay on the beach approaching the dunes and evidence that the beachfront from 30th Street north through the 20s did not suffer a significant impact during the storm.

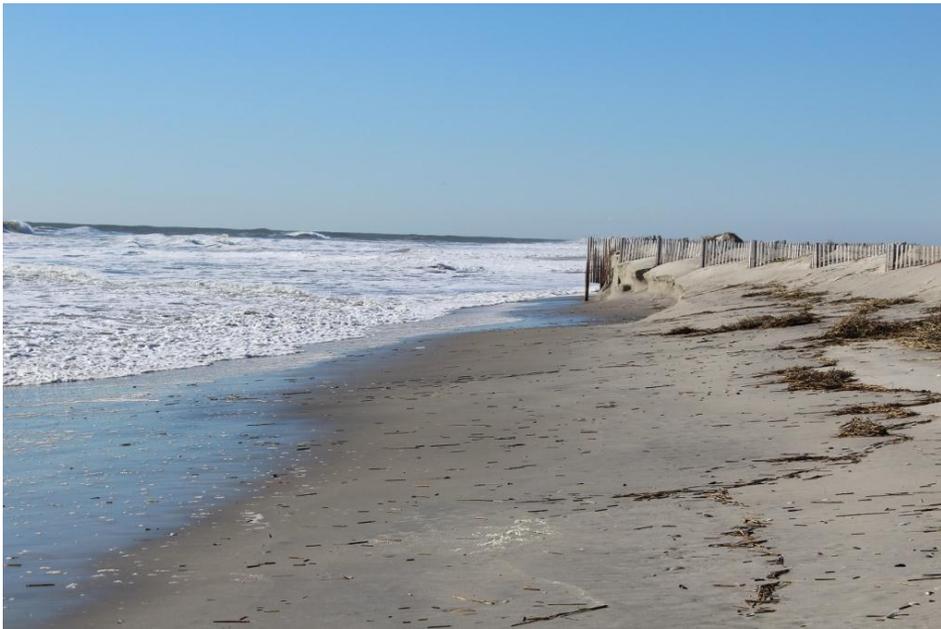
This view is from 11th Street looking south, the most severe erosion area. Sand fence is nearly compromised with salt hay to the dunes, also taken Monday, March 5th. Ironically, significant erosion occurred from late Saturday through Monday morning when the weather effects of the storm had passed.

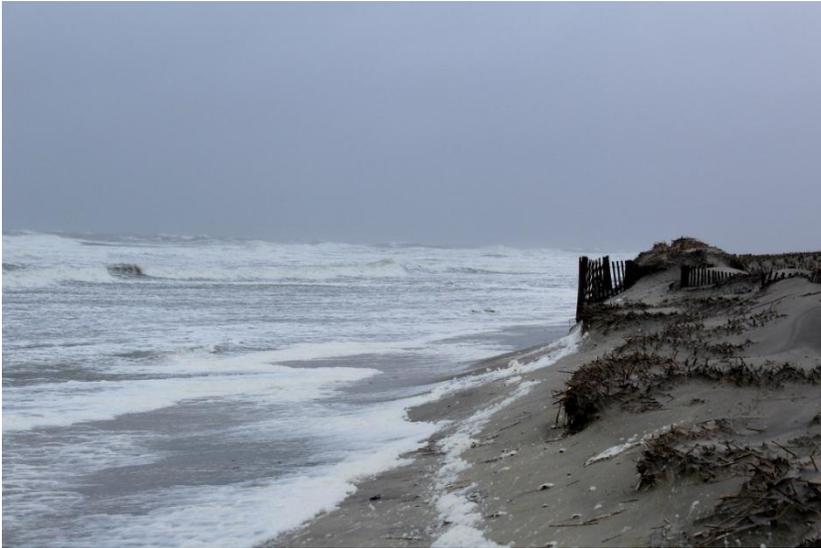
Avalon's 11th Street beach during storm event Wednesday, March 21st. Strong wind and wave action brought the surf closer to the dunes with salt hay deposited at the toe of the dunes.

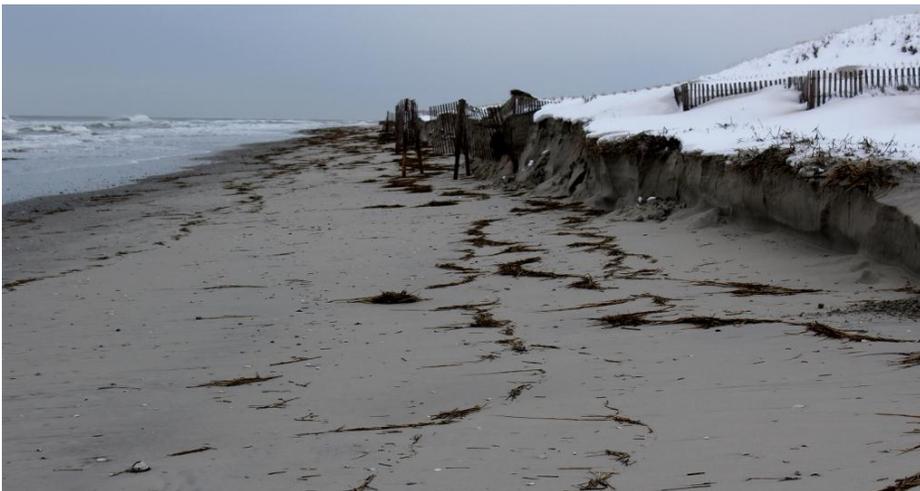
Avalon's 10th Street beach looking south through erosion zone taken Thursday, March 22nd. Wave action clipped the toe of the dune and damaged some sand face that was installed. Wrack line appears to be beyond the toe of the dune.

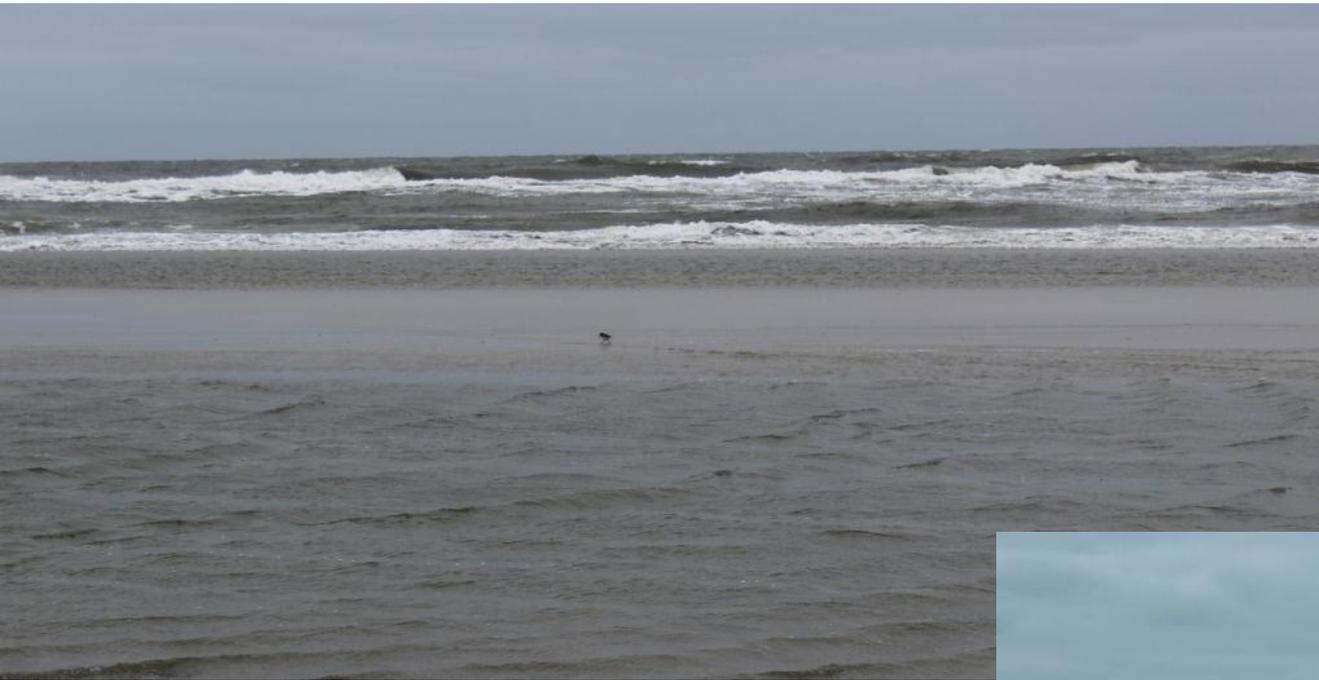
A large amount of sand transported to the borrow area. The photo (left) taken Monday, March 26th and shows a bird on a sandbar at 35th Street. A large sandbar formed after Nor'easter #1 that used to be the north end beach fill project.

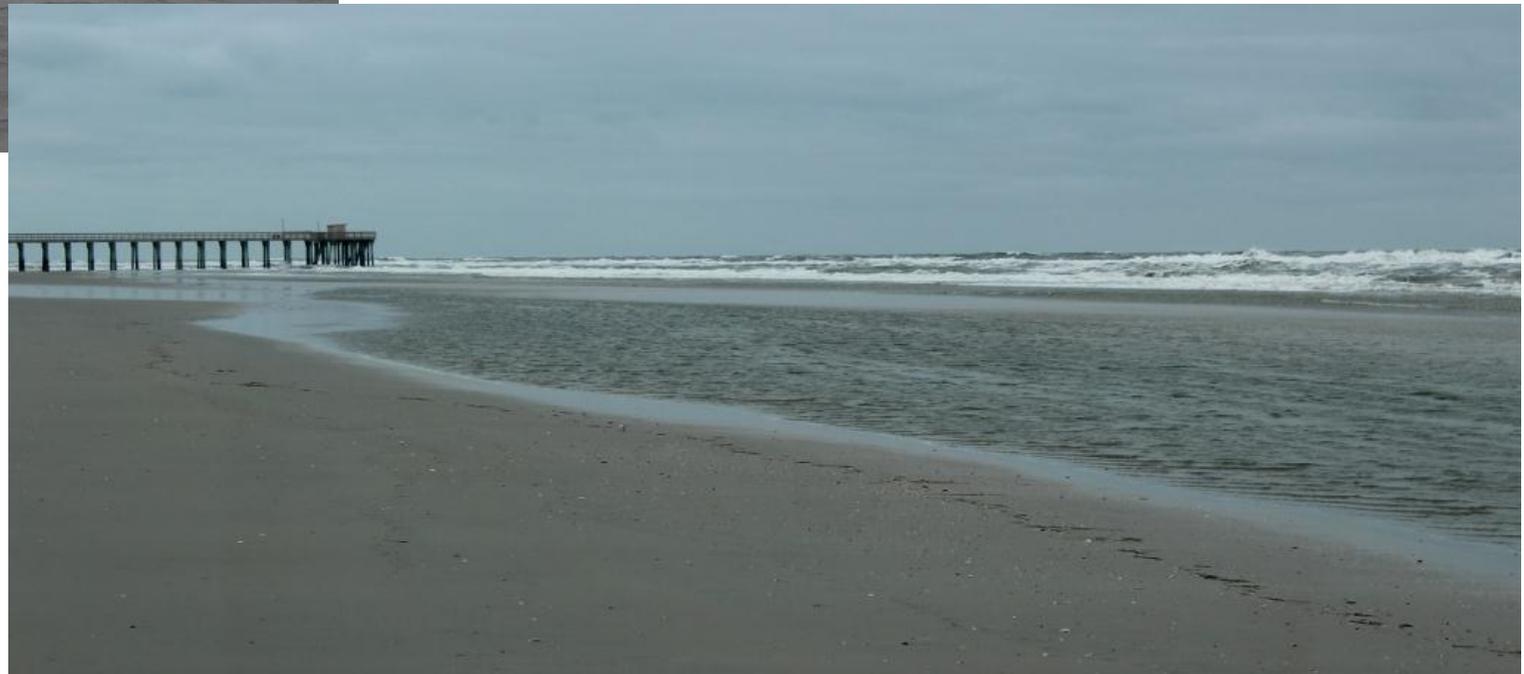
Evidence of the large gully forming on the beaches near the north borrow area absent of any backpassing activity since June, 2016.

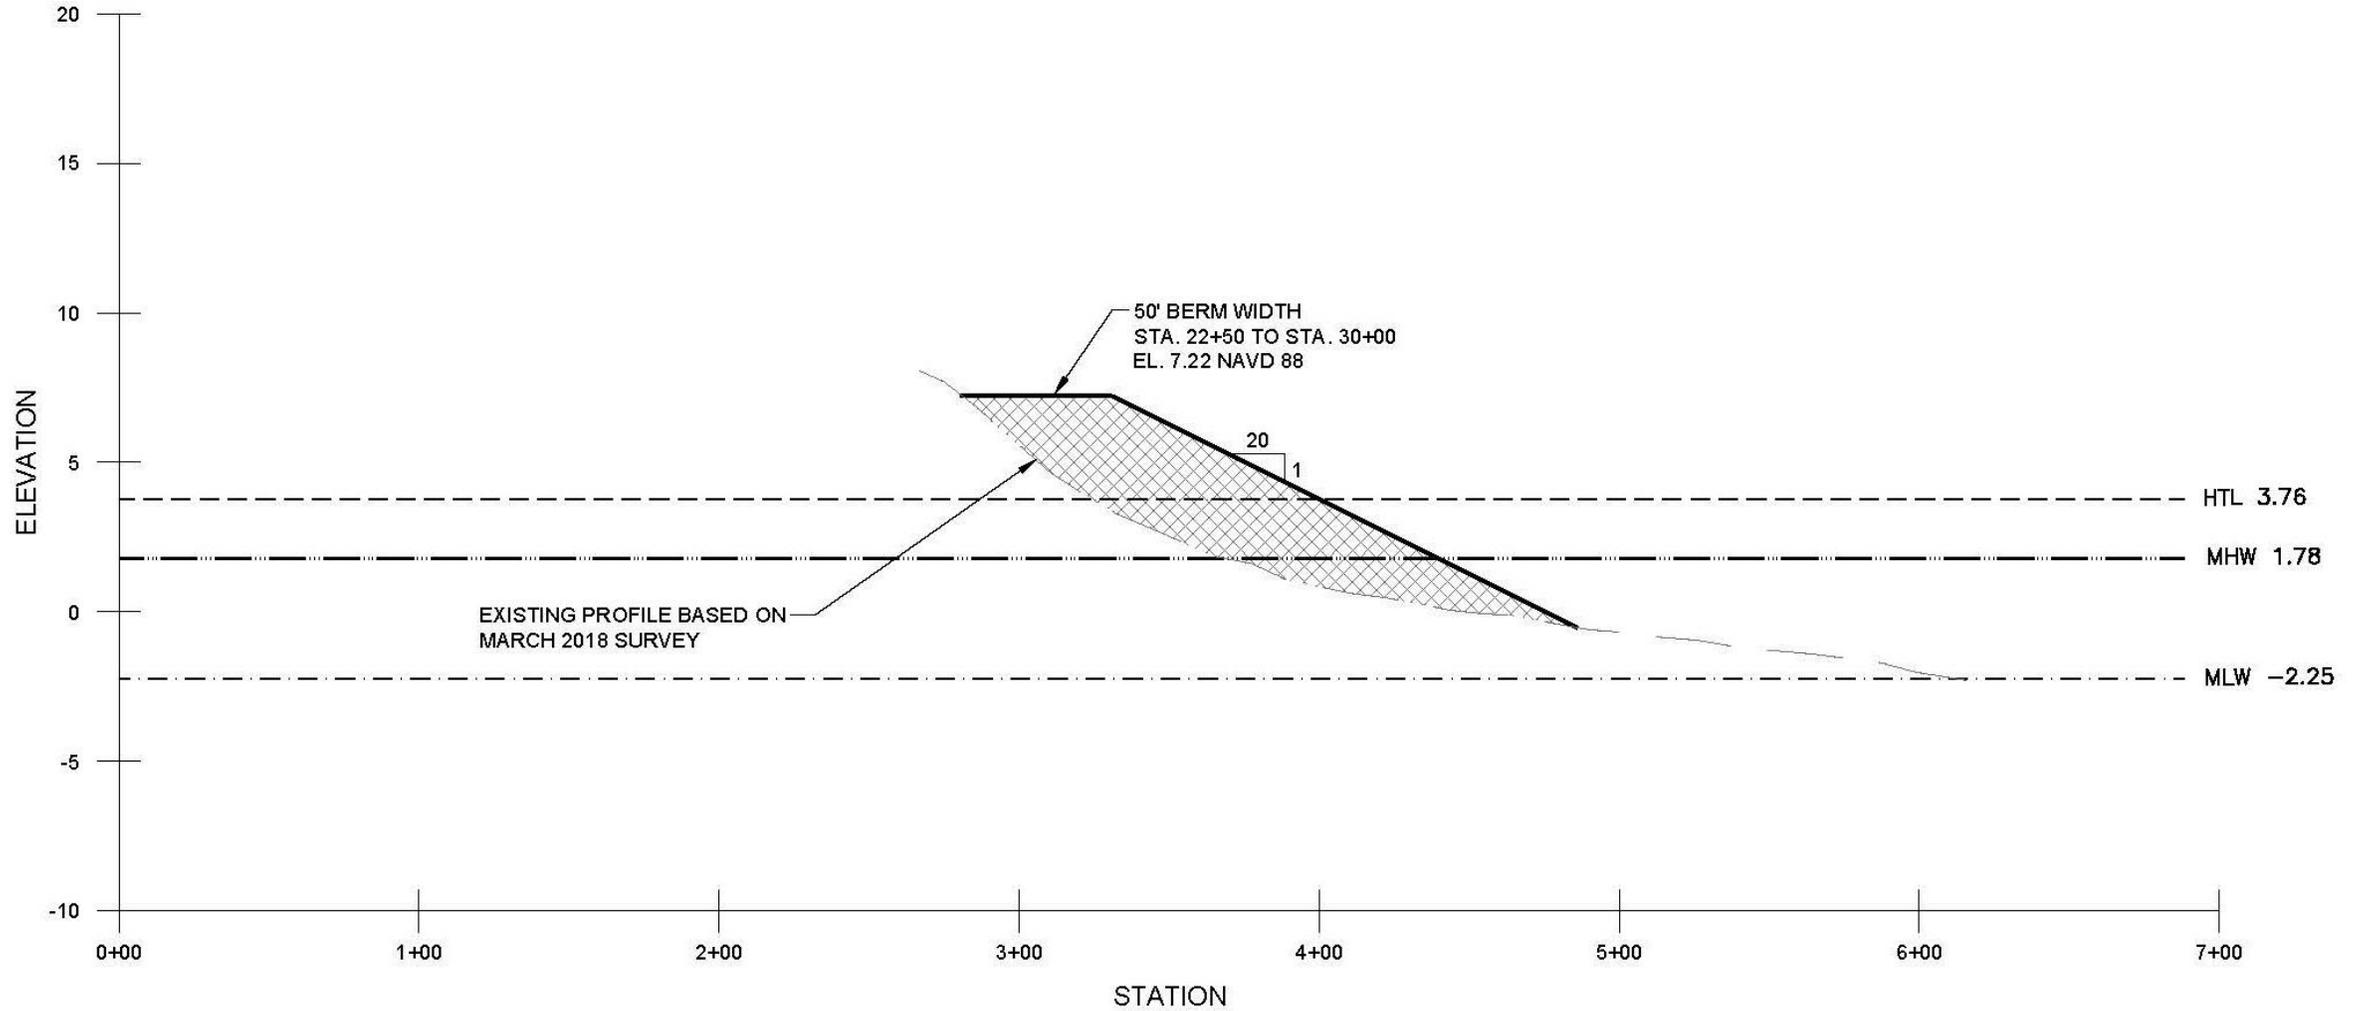
TYPICAL FILL AREA PROFILE

Typical Fill Area Profile/Backpassing
